AML Project 17.6B

Glenrock Emergency Subsidence Mitigation

Fact Sheet

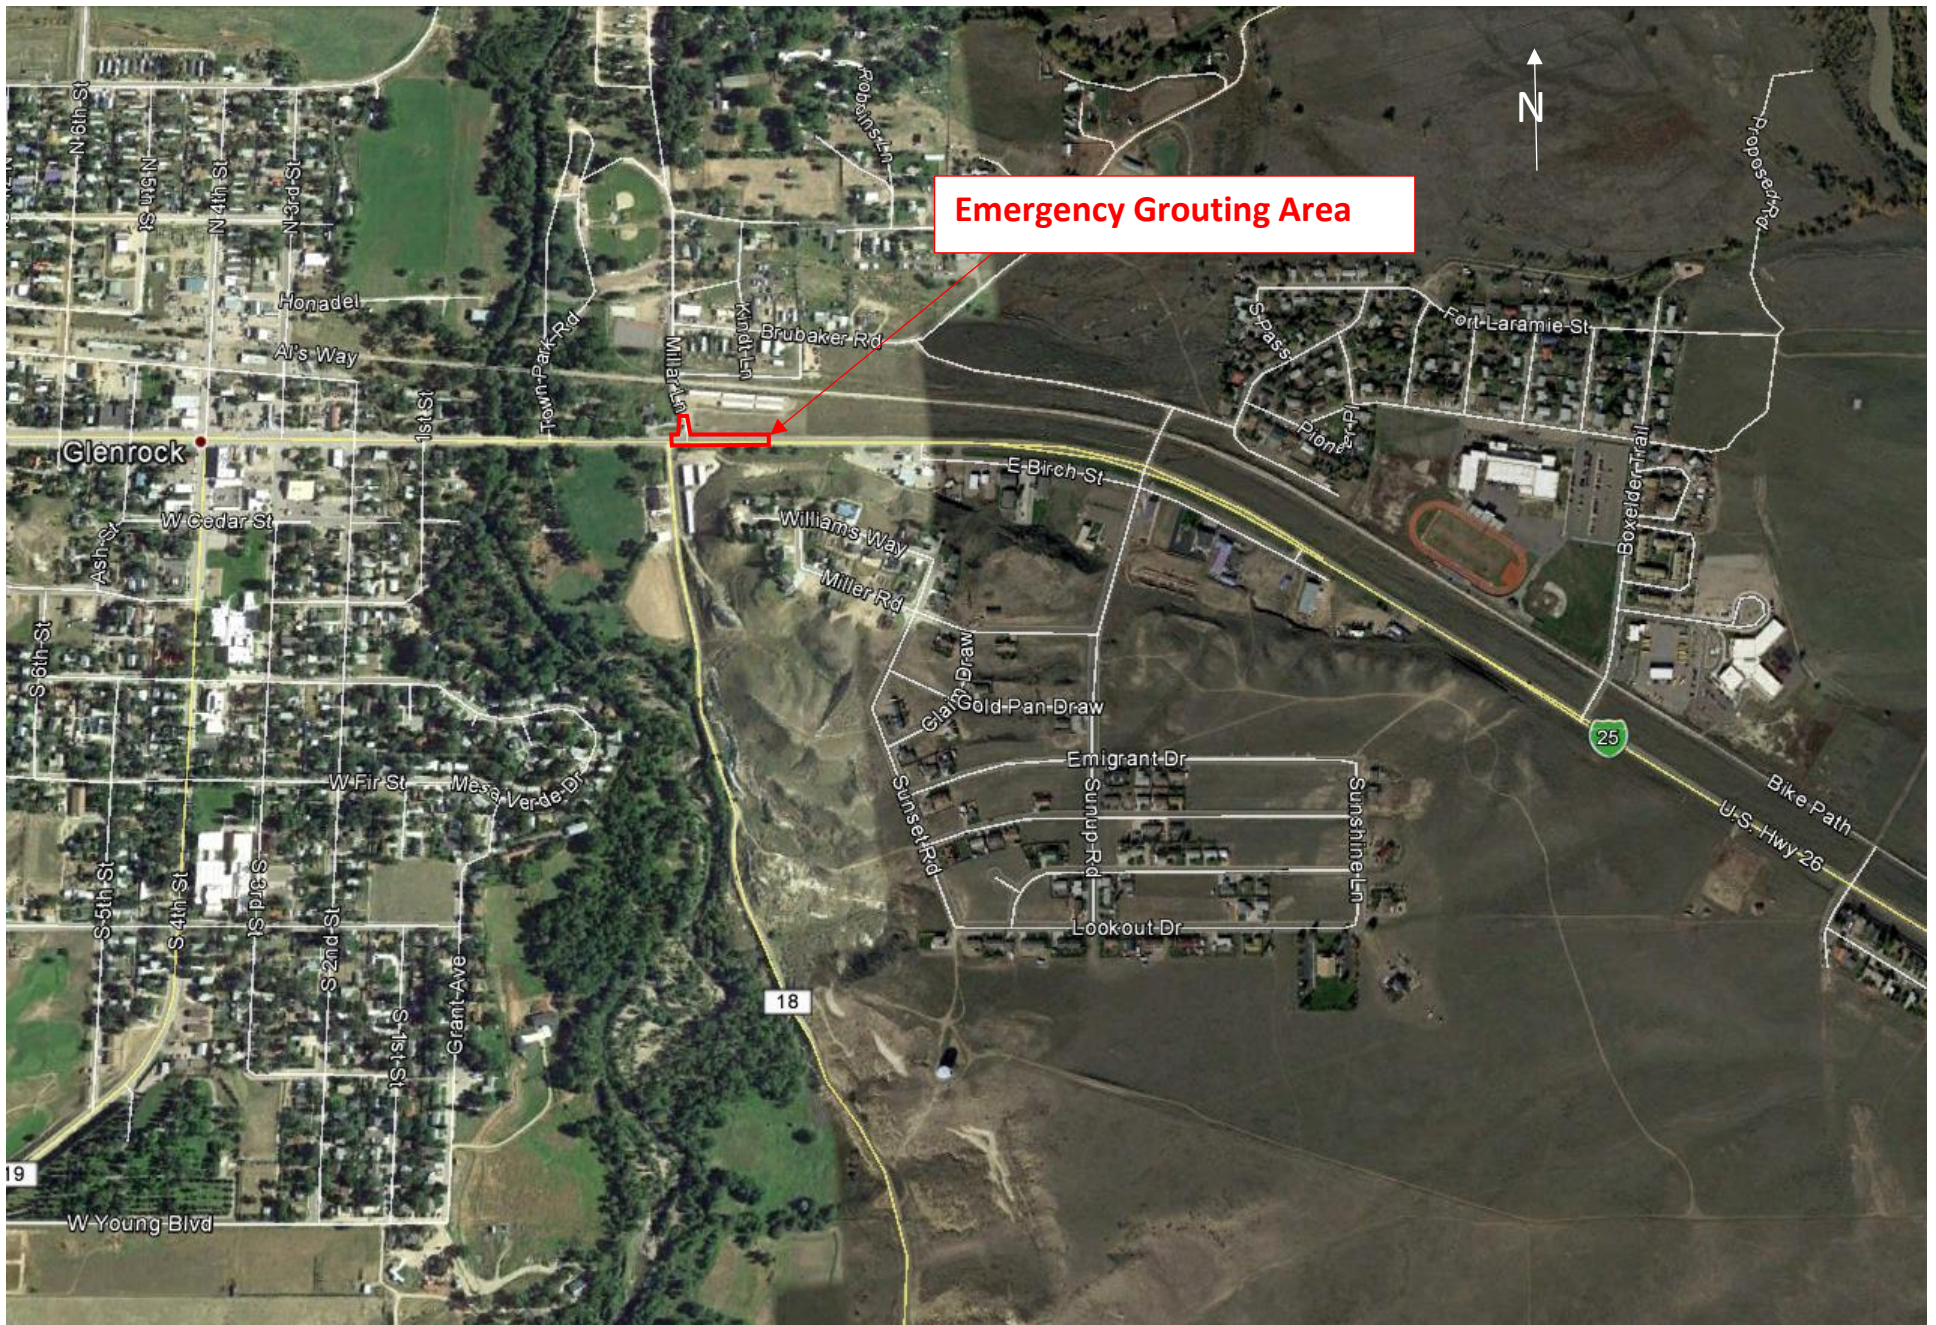
Figure 1 – Emergency Grouting Project Location, East Glenrock, WY

- AML Project 17.6B Emergency Grouting is being conducted at the intersection of Millar lane/Mormon Canyon Road and the I-25 Bypass (SH 20-26-87) in east Glenrock and extending east approximately 500 feet from the intersection, encompassing an area of roughly 0.67 acres (Figure 1).

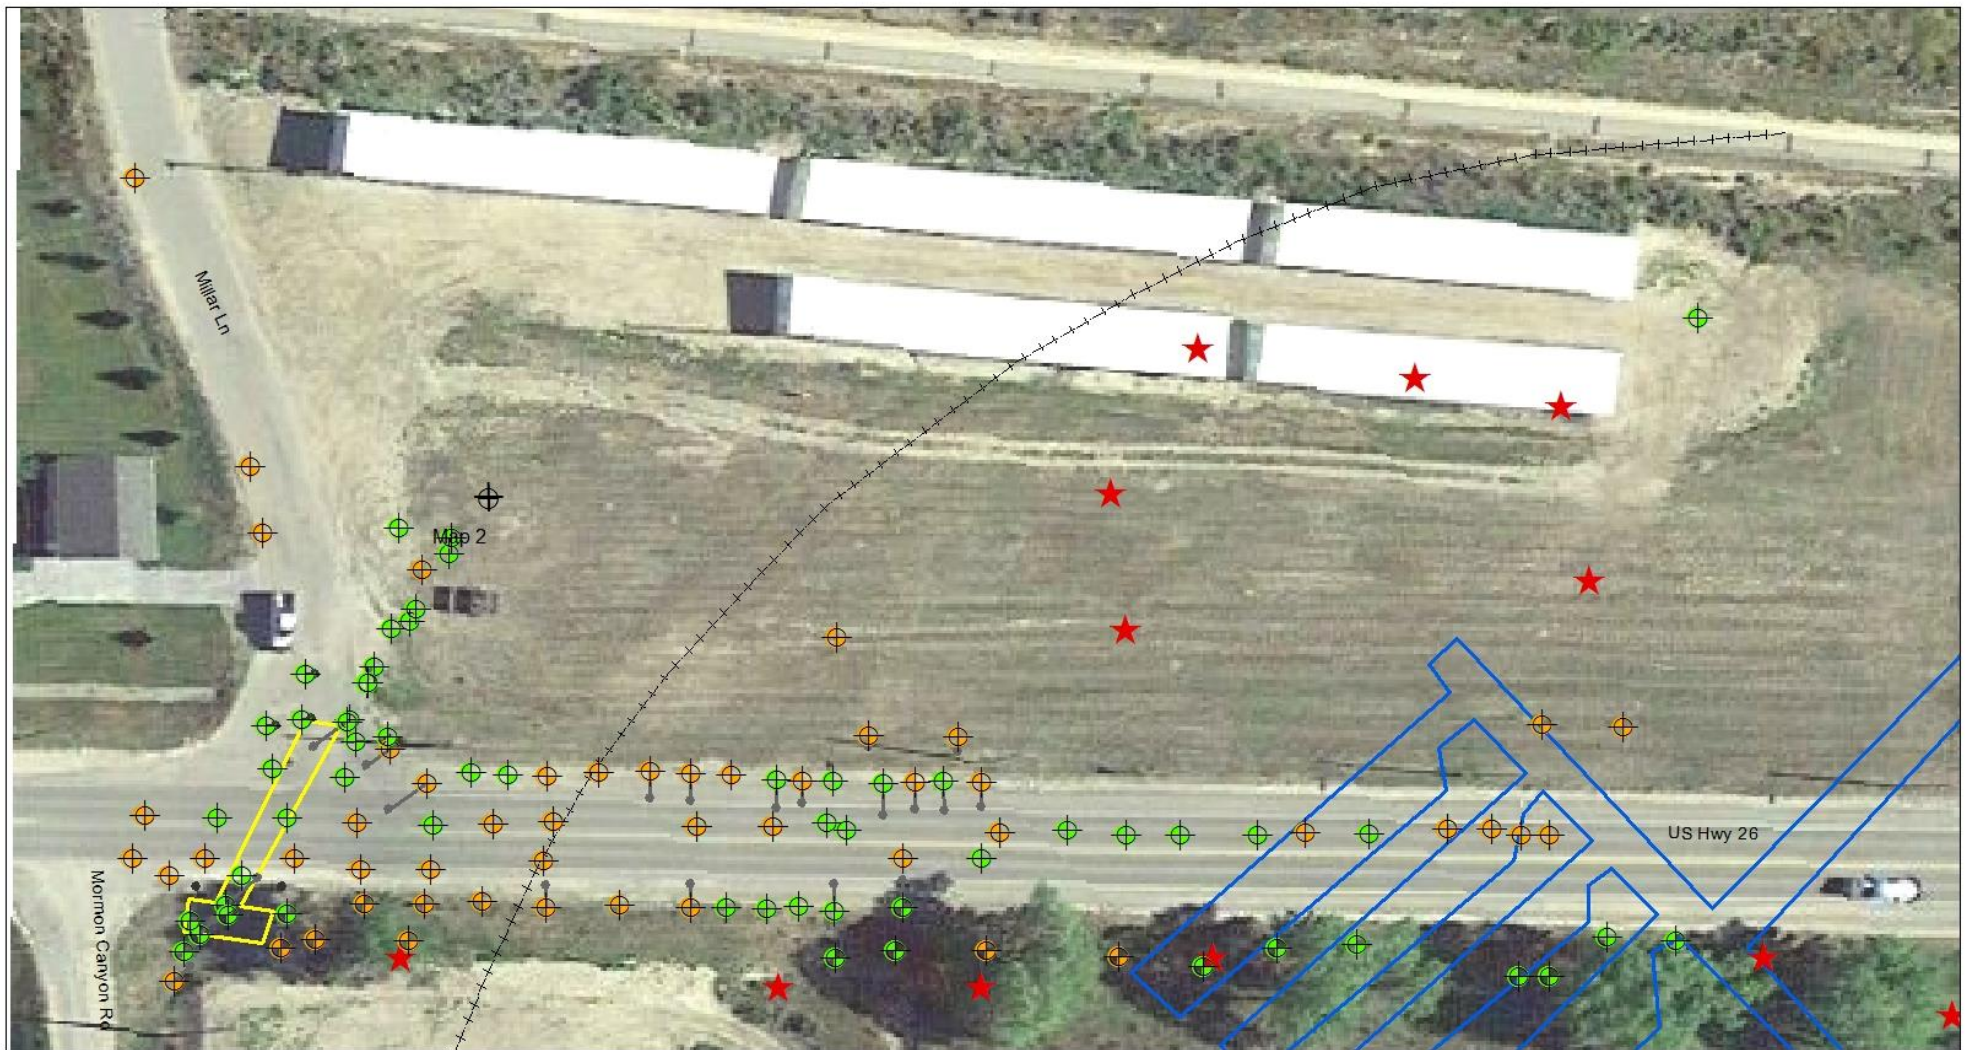
Figure 2 – Emergency Grouting Area Detail

- Emergency grouting has included drilling more than 130 boreholes (Figure 2). This required coordinating with WYDOT and GE Wind for temporary lane closures while drilling and grouting directly beneath the highway.

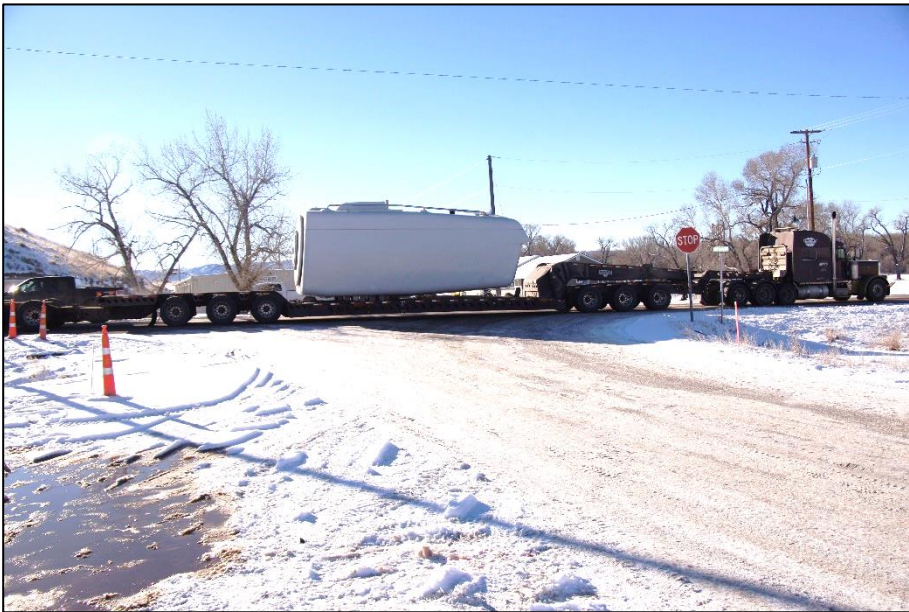
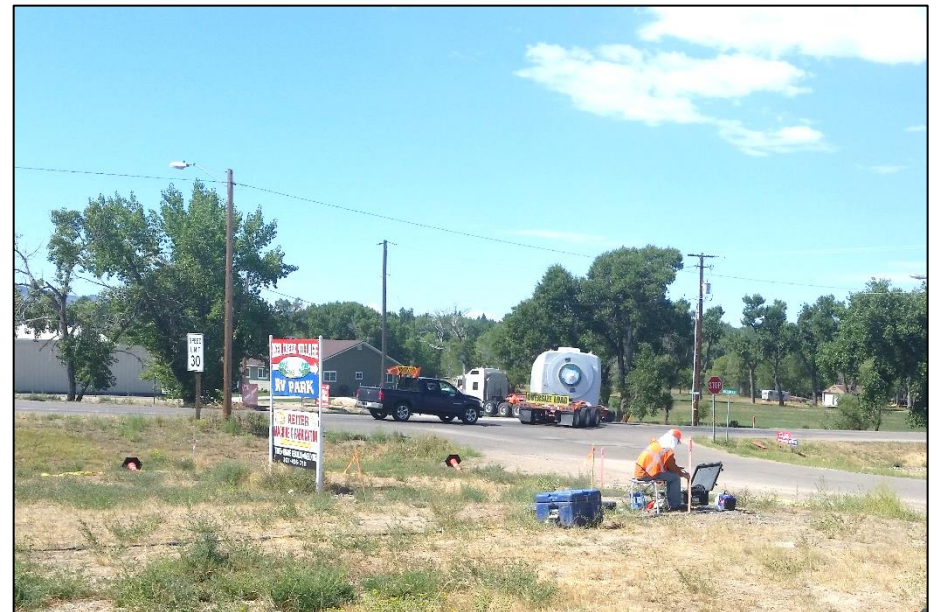
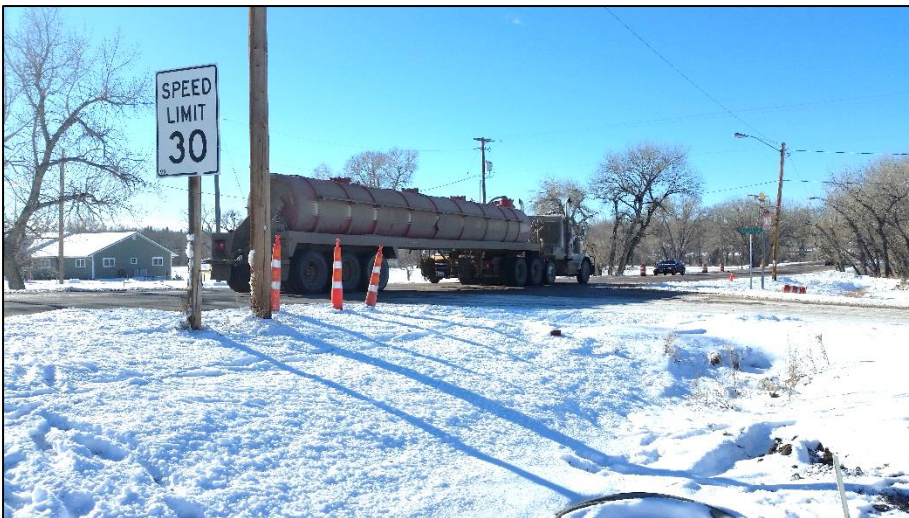
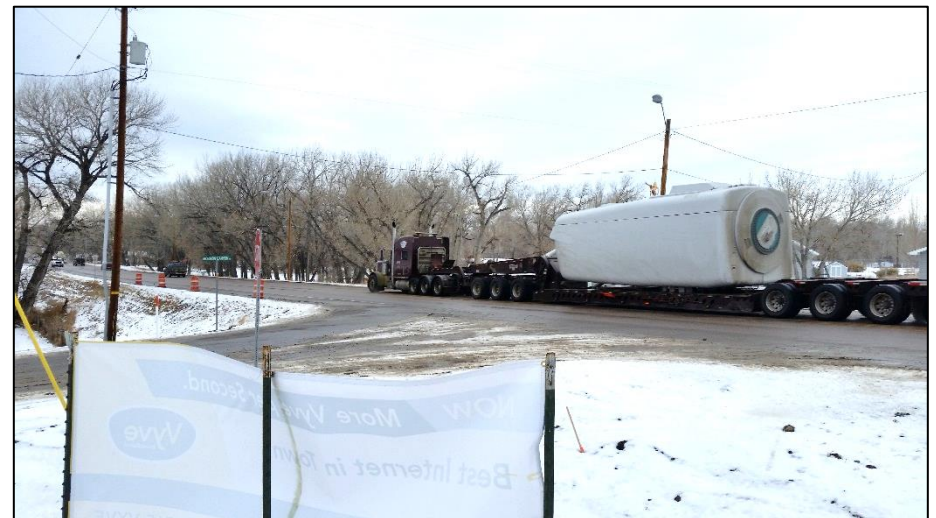
State Highway 20-26-87/I-25 Business Route

Main artery through the area that is subject to a considerable amount of traffic. This includes heavy transports for the wind turbines at two separate wind farms under construction in 2106; one several miles south on Mormon Canyon Road, and the other northwest of Glenrock in the Rollins Hills area.

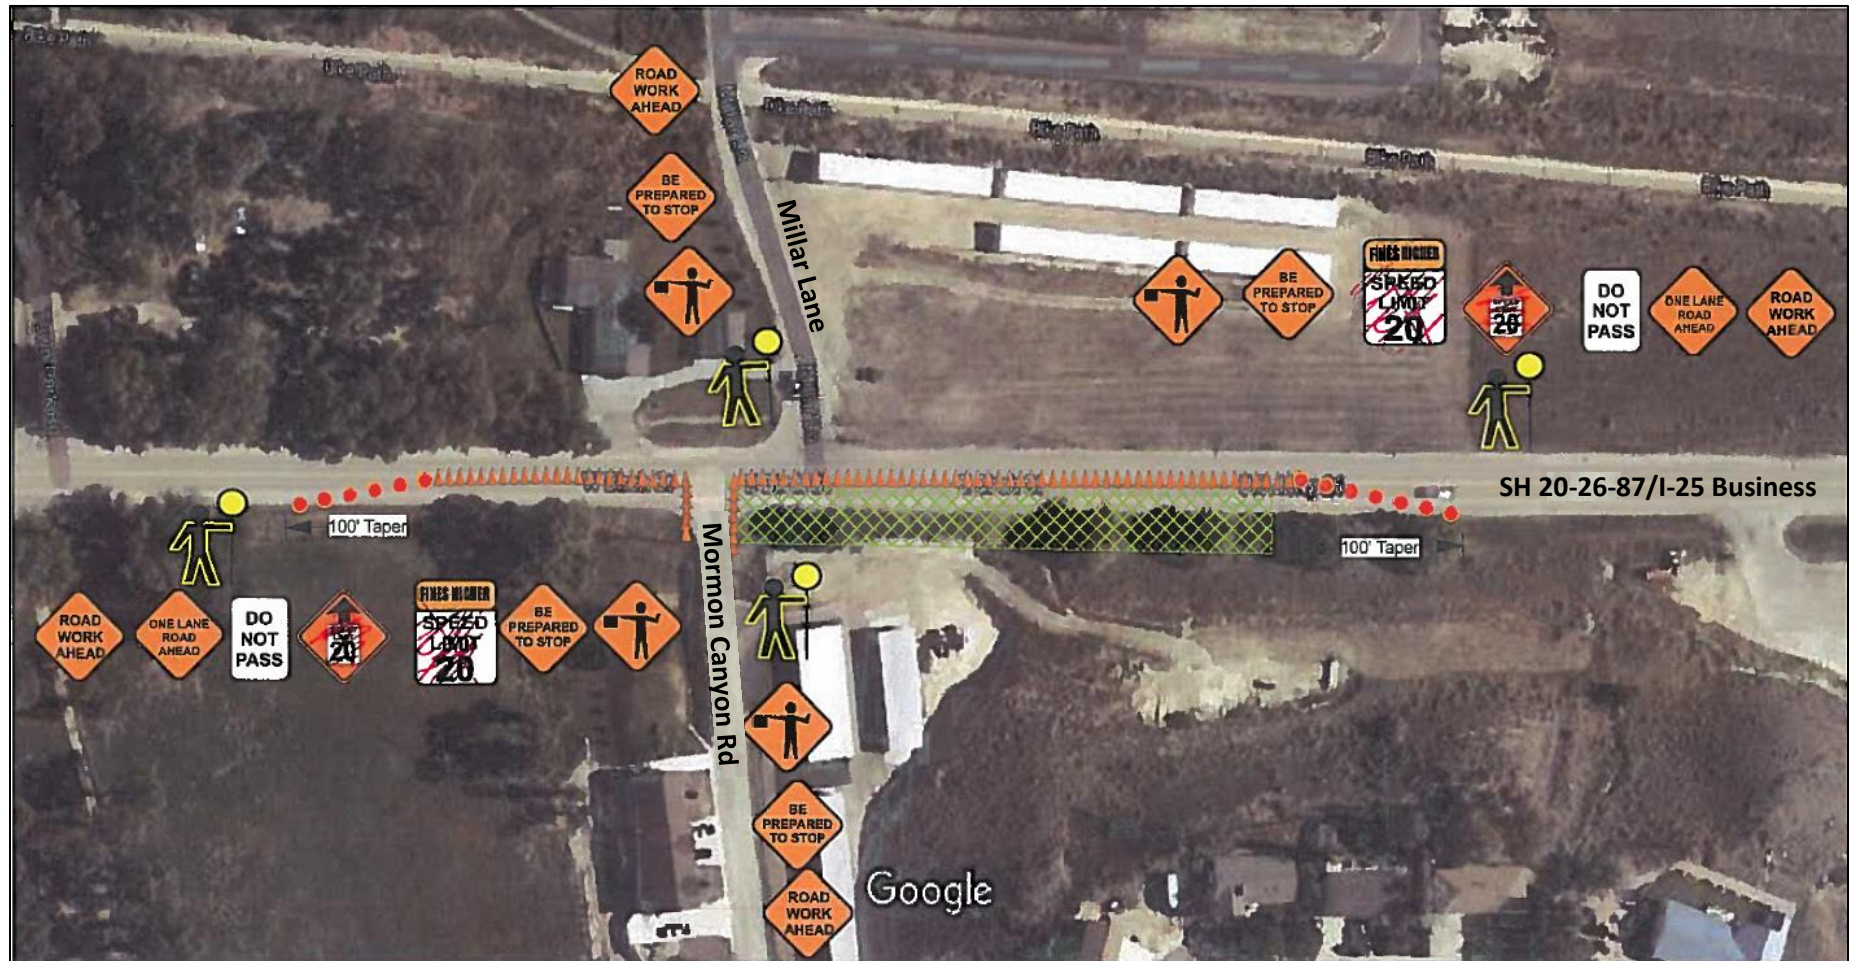
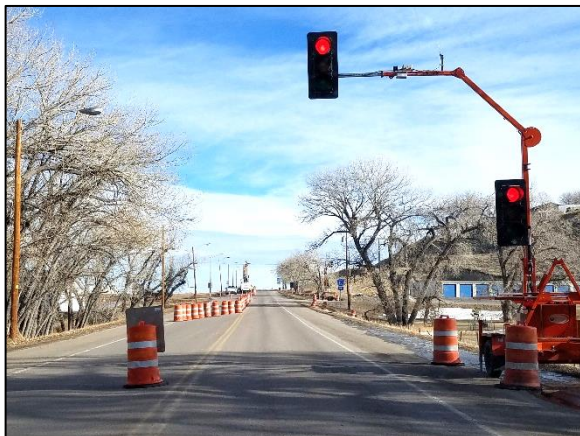
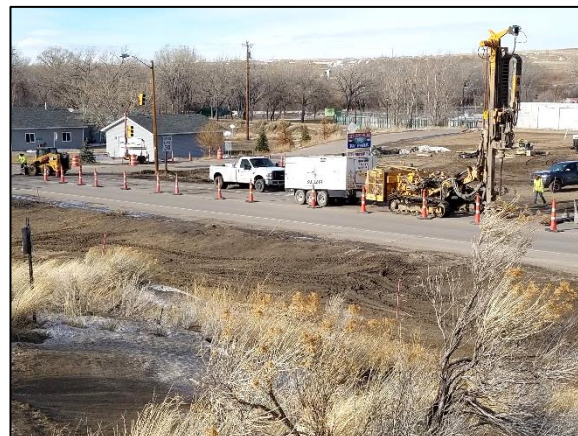
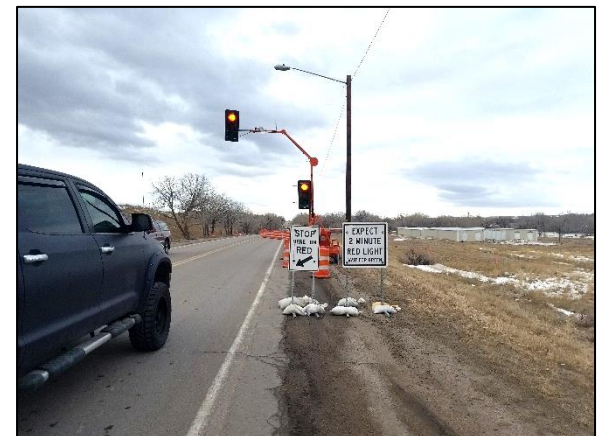
Traffic Control During Grouting Operations

Single lane closure with automated signal light coordinated and permitted with WYDOT, and with GE Wind.
